# NATIONAL BUREAU OF STANDARDS REPORT

8975

## Investigation of Performance Characteristics for Sanitary Plumbing Fixtures

Building Research Division  
Institute for Applied Technology

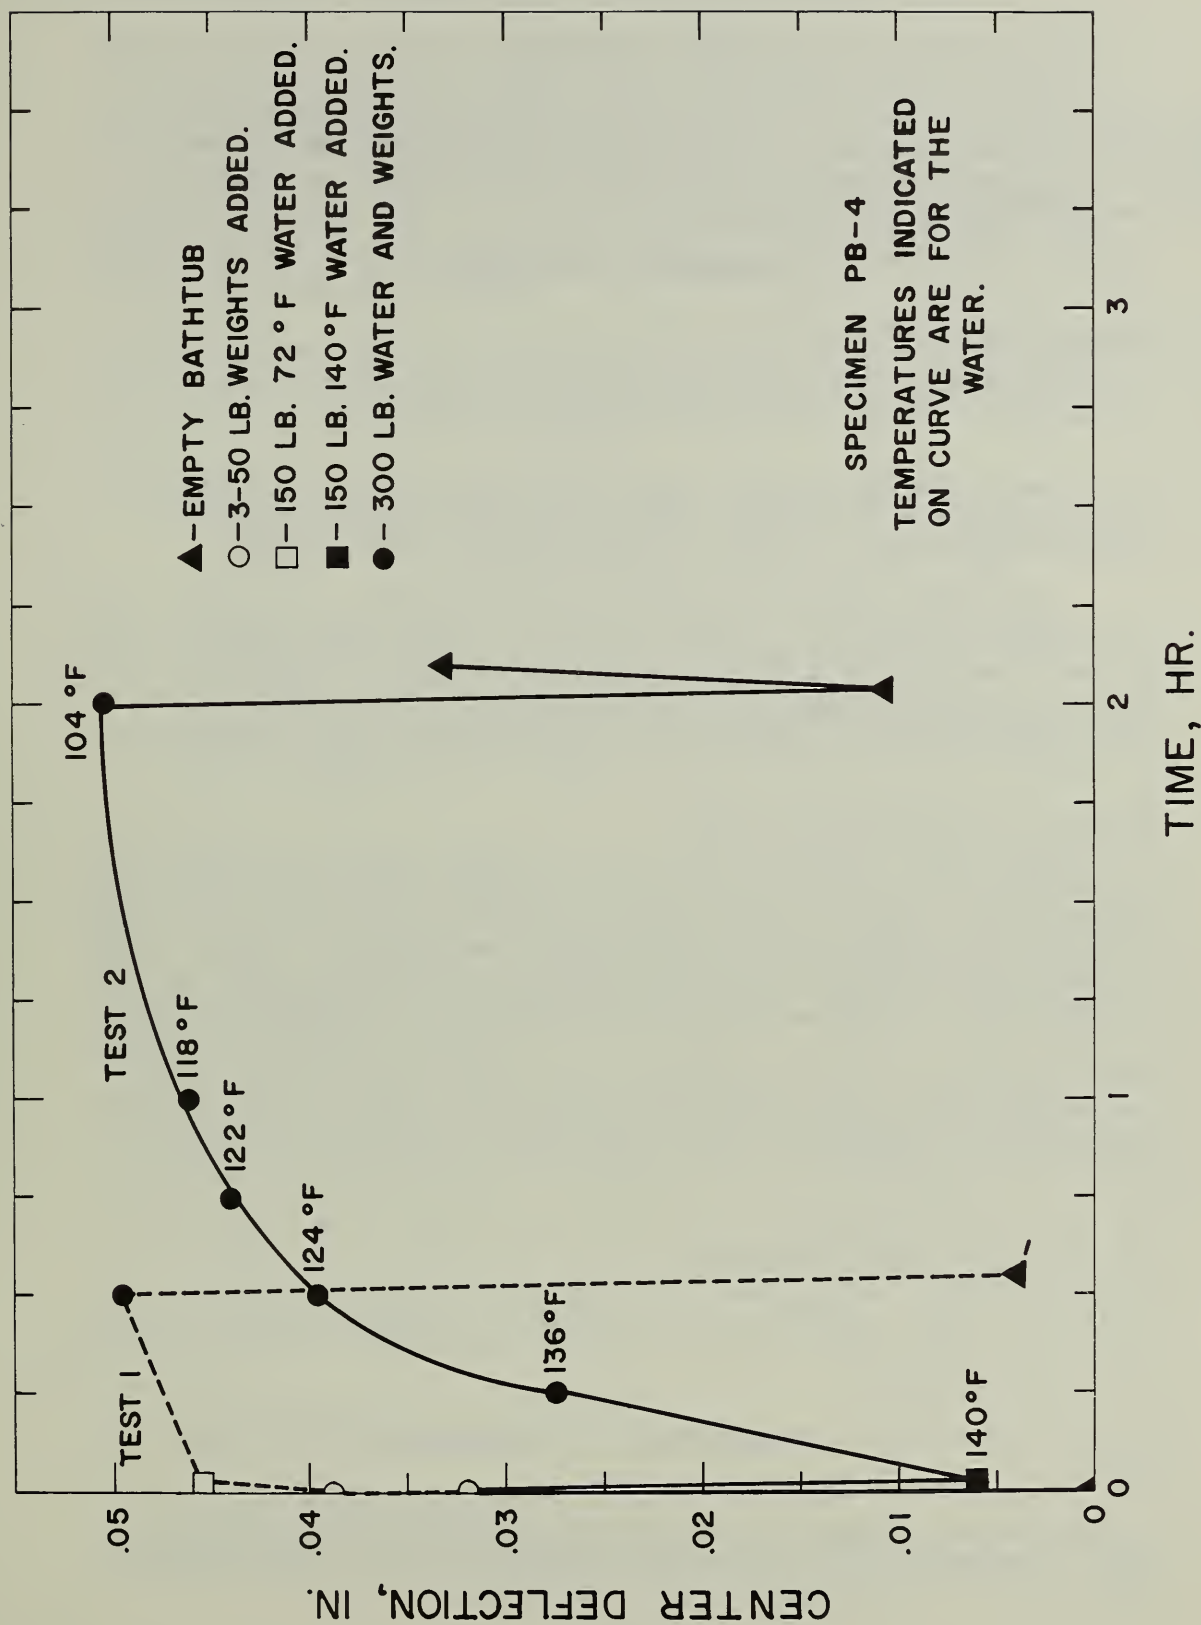
FIG. 2.1-1 EFFECT OF TIME ON THE CENTER DEFLECTION OF AN FRPE TUB WITH WARM AND COLD WATER LOAD.

Load tests were made on three FRPE tubs to determine the effect of a hot-water load on deflections. For these tests 150-lb of water and three 50-lb cast iron weights were placed in the sump. Deflections and change in deflections with time were measured by using the procedure recommended for the concentrated static load test (Sect. 2.2).

For Test 2 the three 50-lb weights produced a center deflection of 0.032-in, but the addition of the 150-lb of hot water caused an immediate upward movement of 0.026-in. at the center of the sump (indicated by a downward movement on graph). It should be noted that the immediate upward movement of the sump from the hot water load was about double the downward movement from the cool water in Test 1. However, with time the center deflections for both tests approached the same value.

Immediately upon removal of the load in Test 2 the expected upward movement occurred. However, as the tub cooled the thermal gradients caused a downward movement. It is unfortunate that measurements were not continued for a longer period, but from other test results there is not much doubt that the sump would gradually return to a position close to the original.

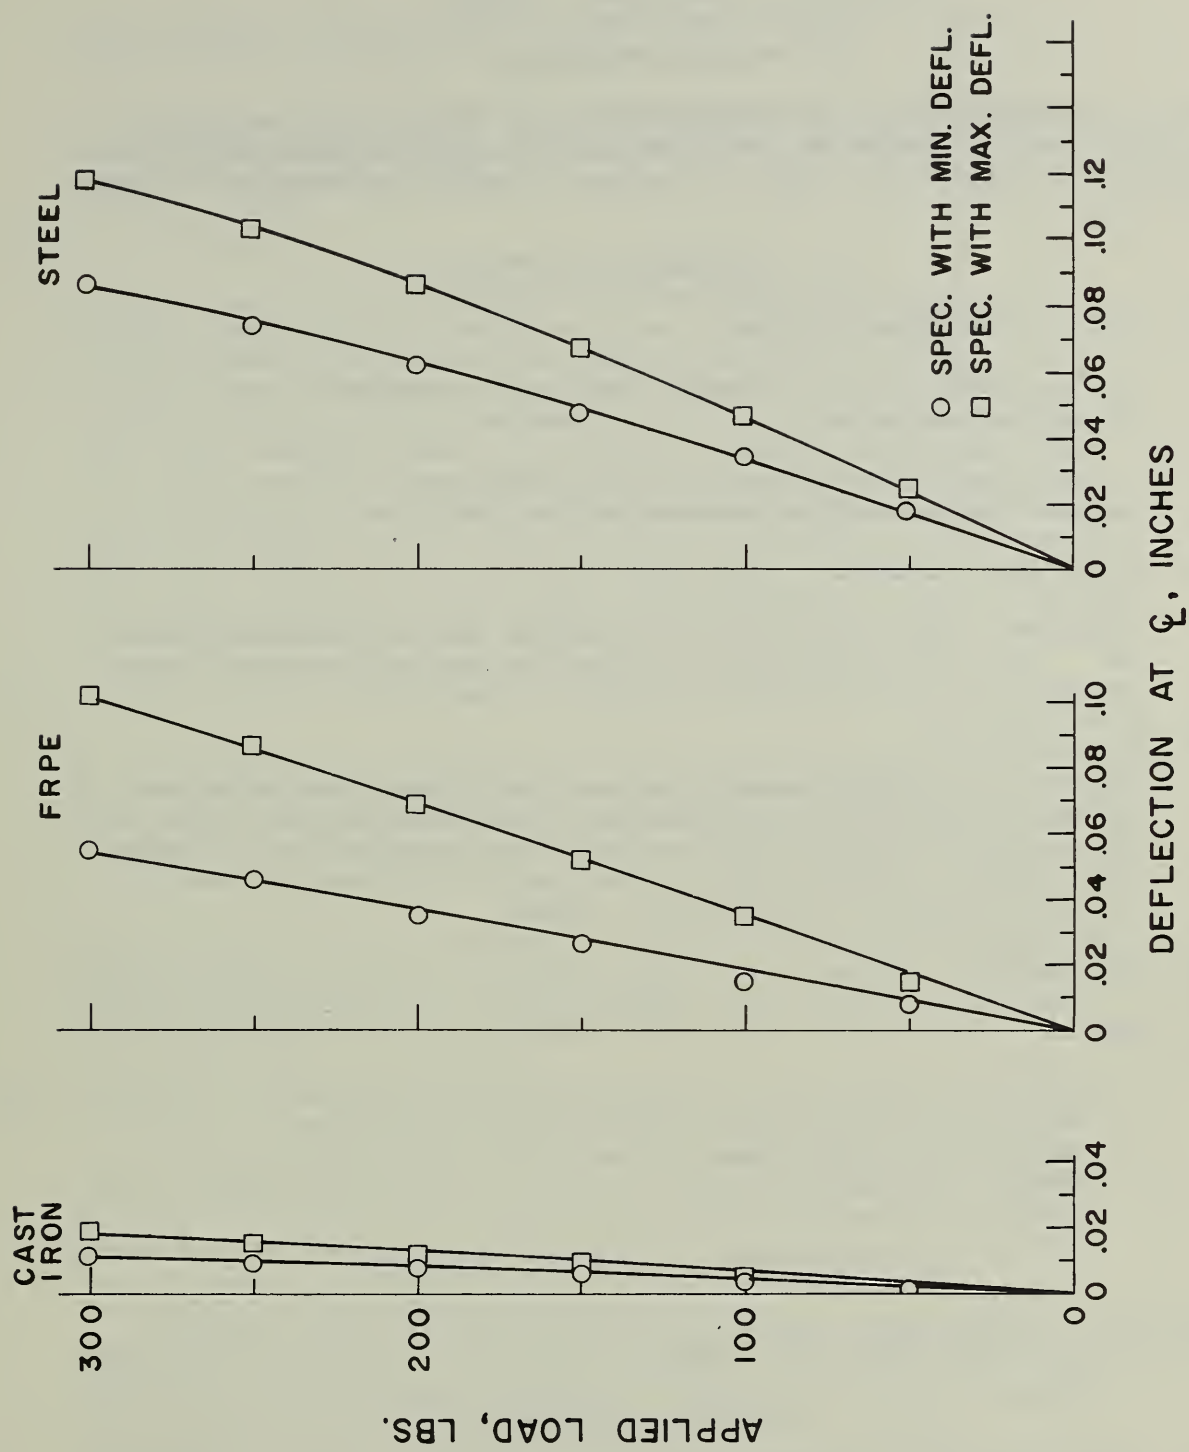
FIG. 2.2-1 CONCENTRATED LOAD TEST (STATIC) 50 SQ. IN. AREA.

The relationship between the applied loads and deflections are shown in Fig. 2.2-1. Each pair of curves represent the maximum and minimum deflections observed during tests of bathtubs manufactured from the materials designated. The observed deflections for individual units tested appear in Table 2.2-1.

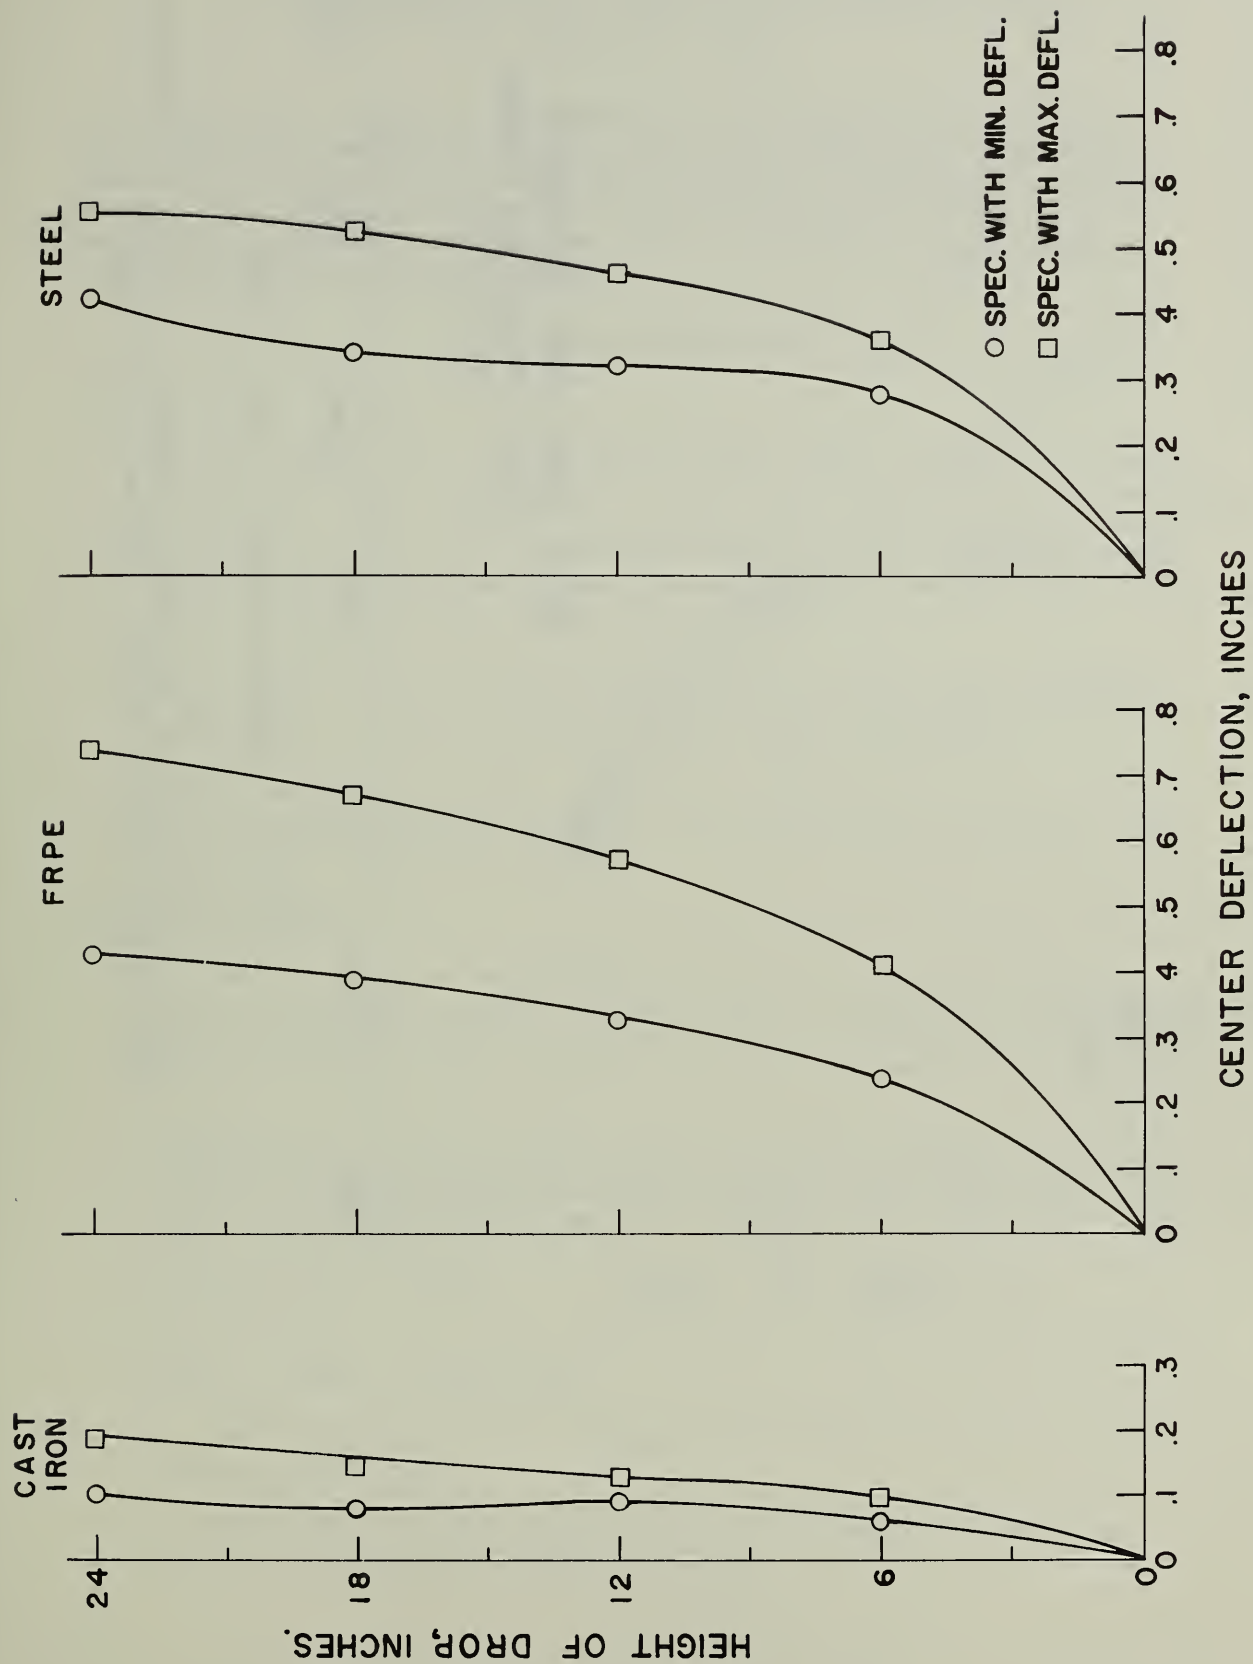
FIG. 2.4-1 CONCENTRATED LOAD TEST (DYNAMIC) 150 LB. LEATHER BAG.

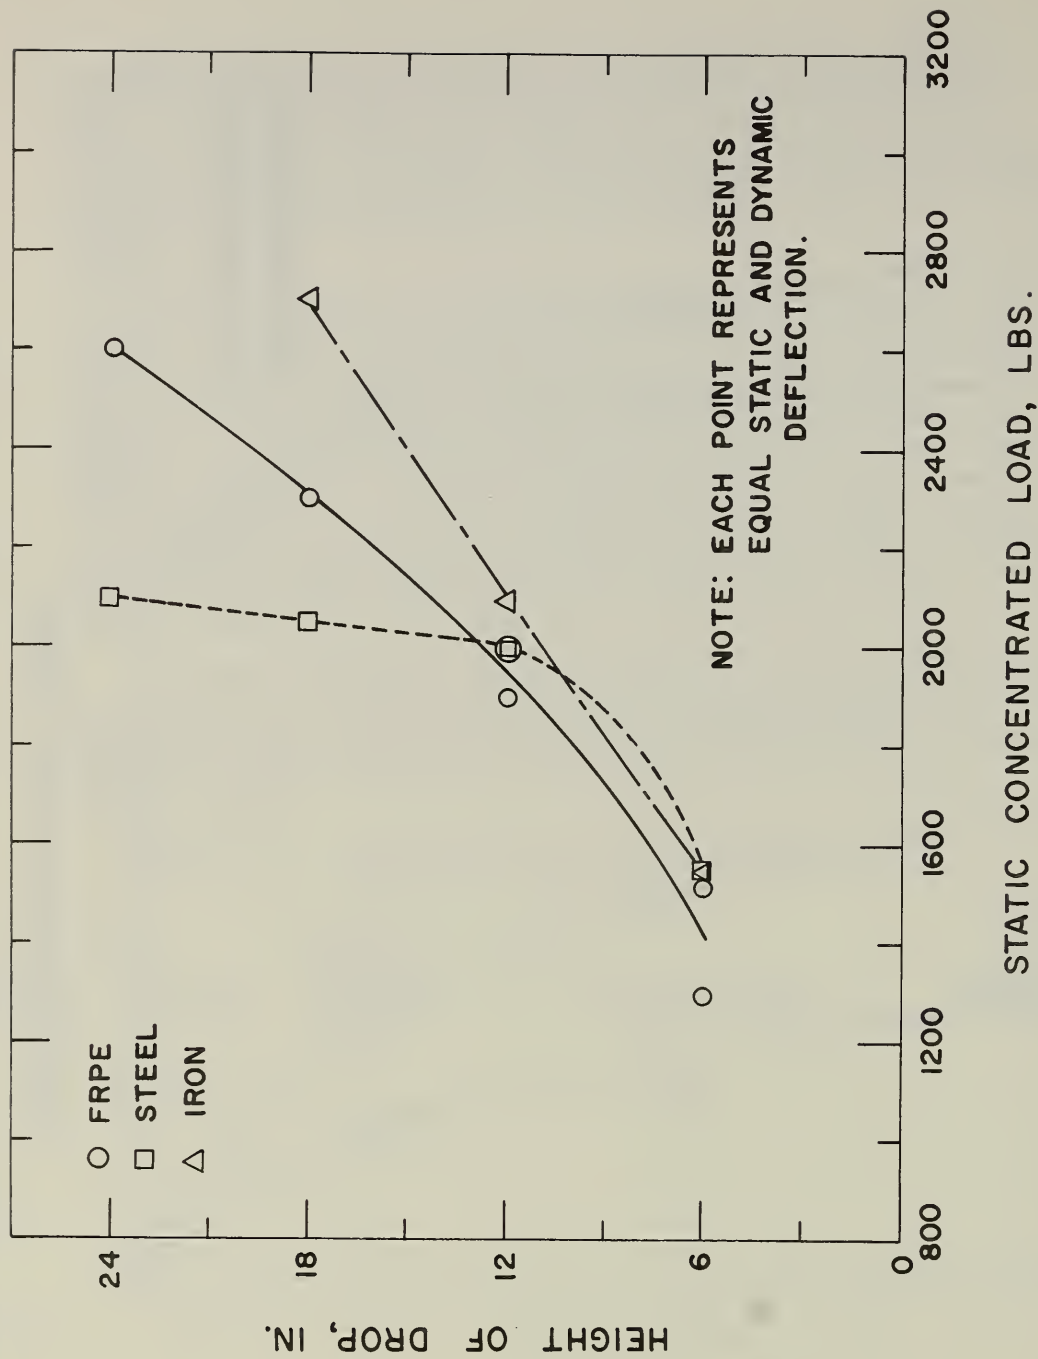
FIG. 2.4-2 CORRELATION BETWEEN HEIGHT OF DROP IN DYNAMIC TEST AND LOAD IN STATIC DESTRUCTIVE TEST.

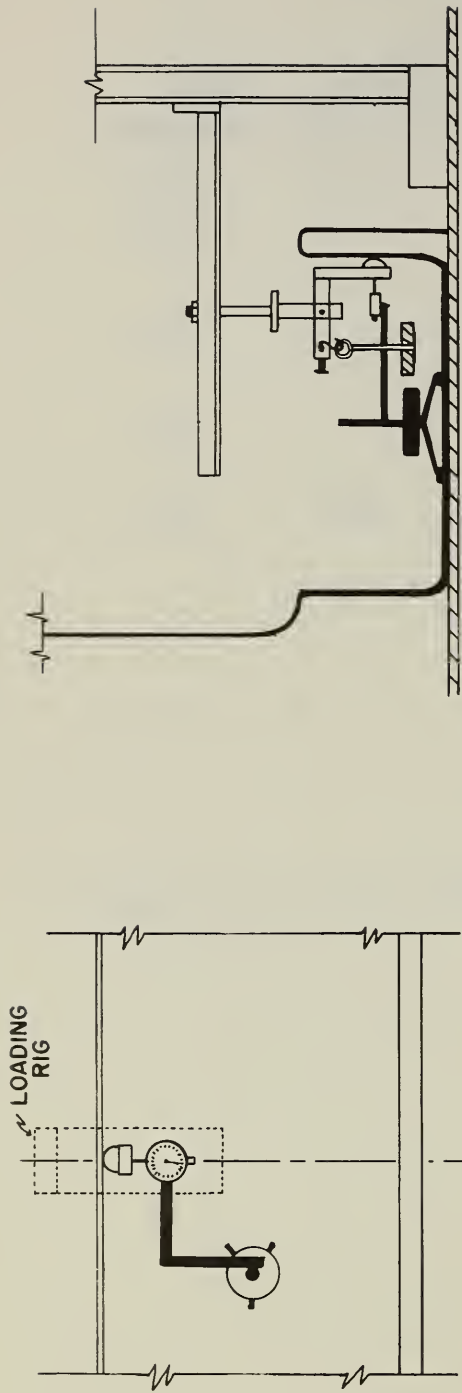
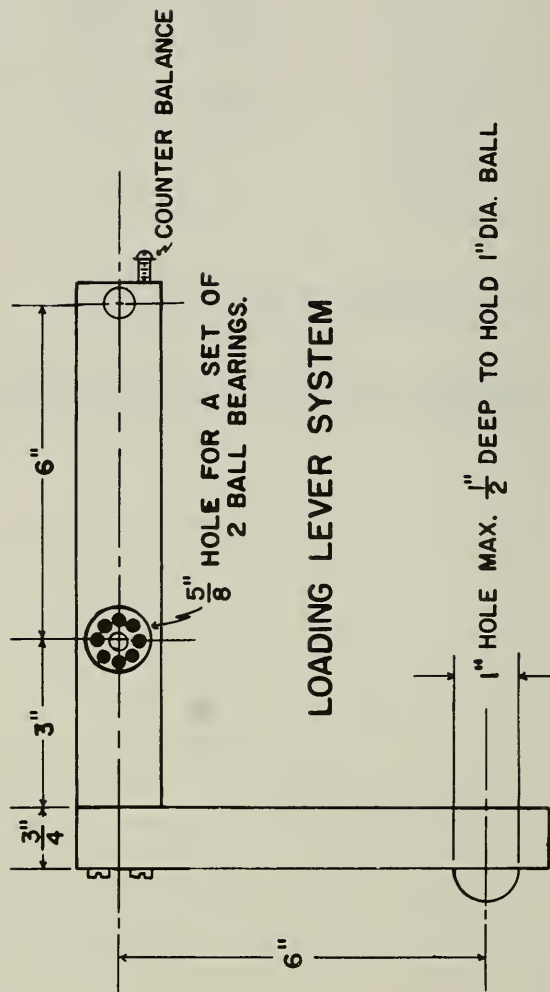
DEFLECTOMETER

VIEW OF LOADING RIG

SCHEMATIC-LOADING SYSTEM

FIG. 2.5-1 DEFLECTION TEST FOR UNSUPPORTED AREA

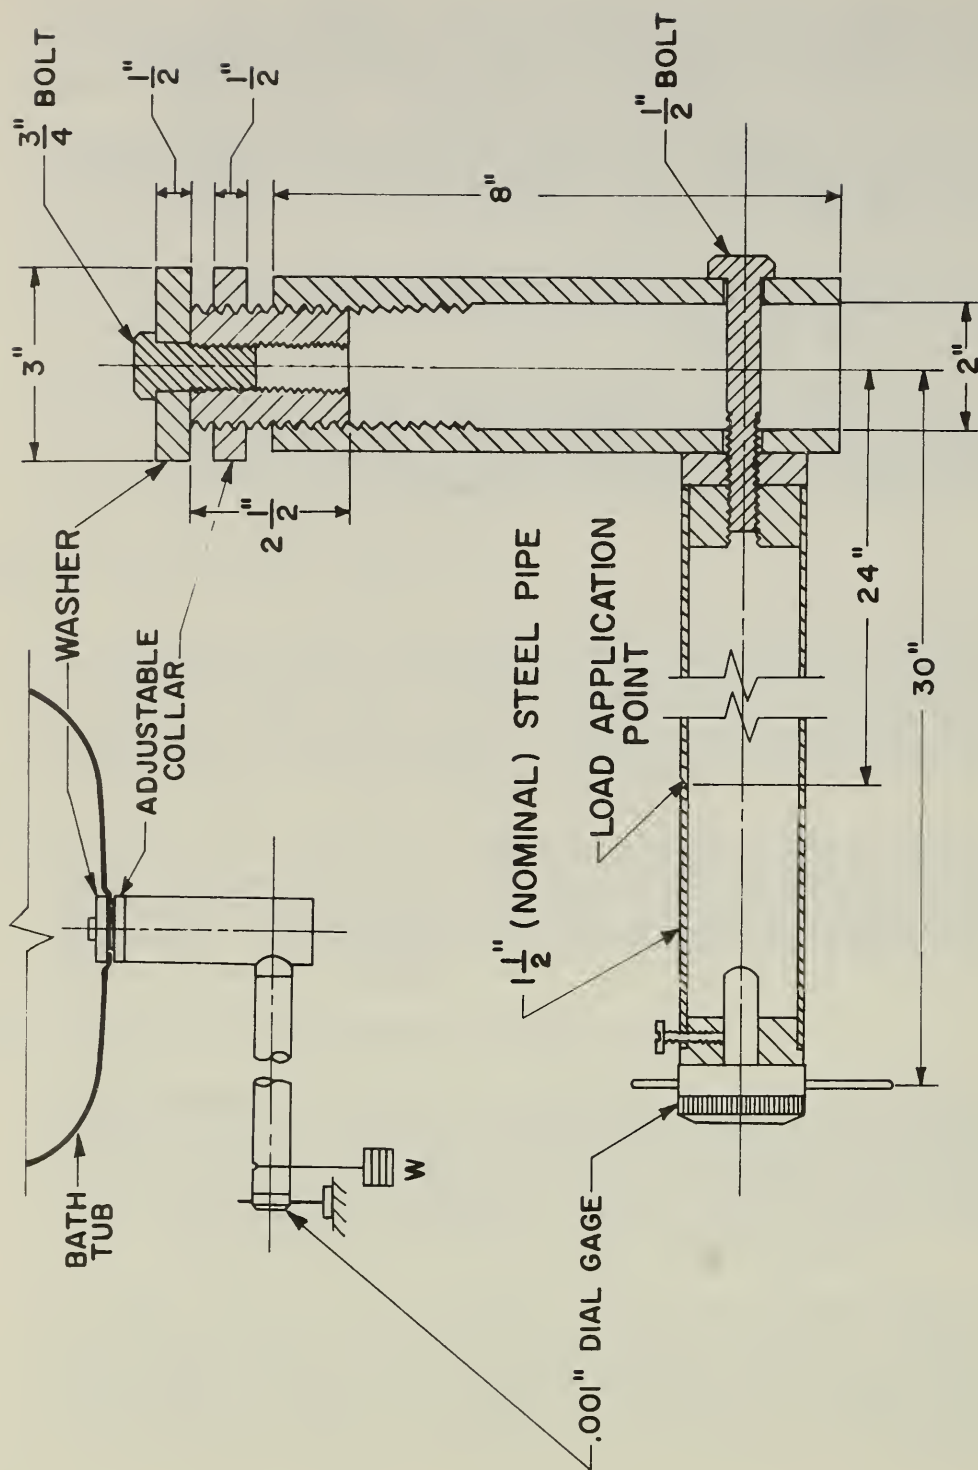
ALL PARTS ARE STEEL

FIG. 2.6-1 APPARATUS FOR DRAIN FITTING LOAD TEST

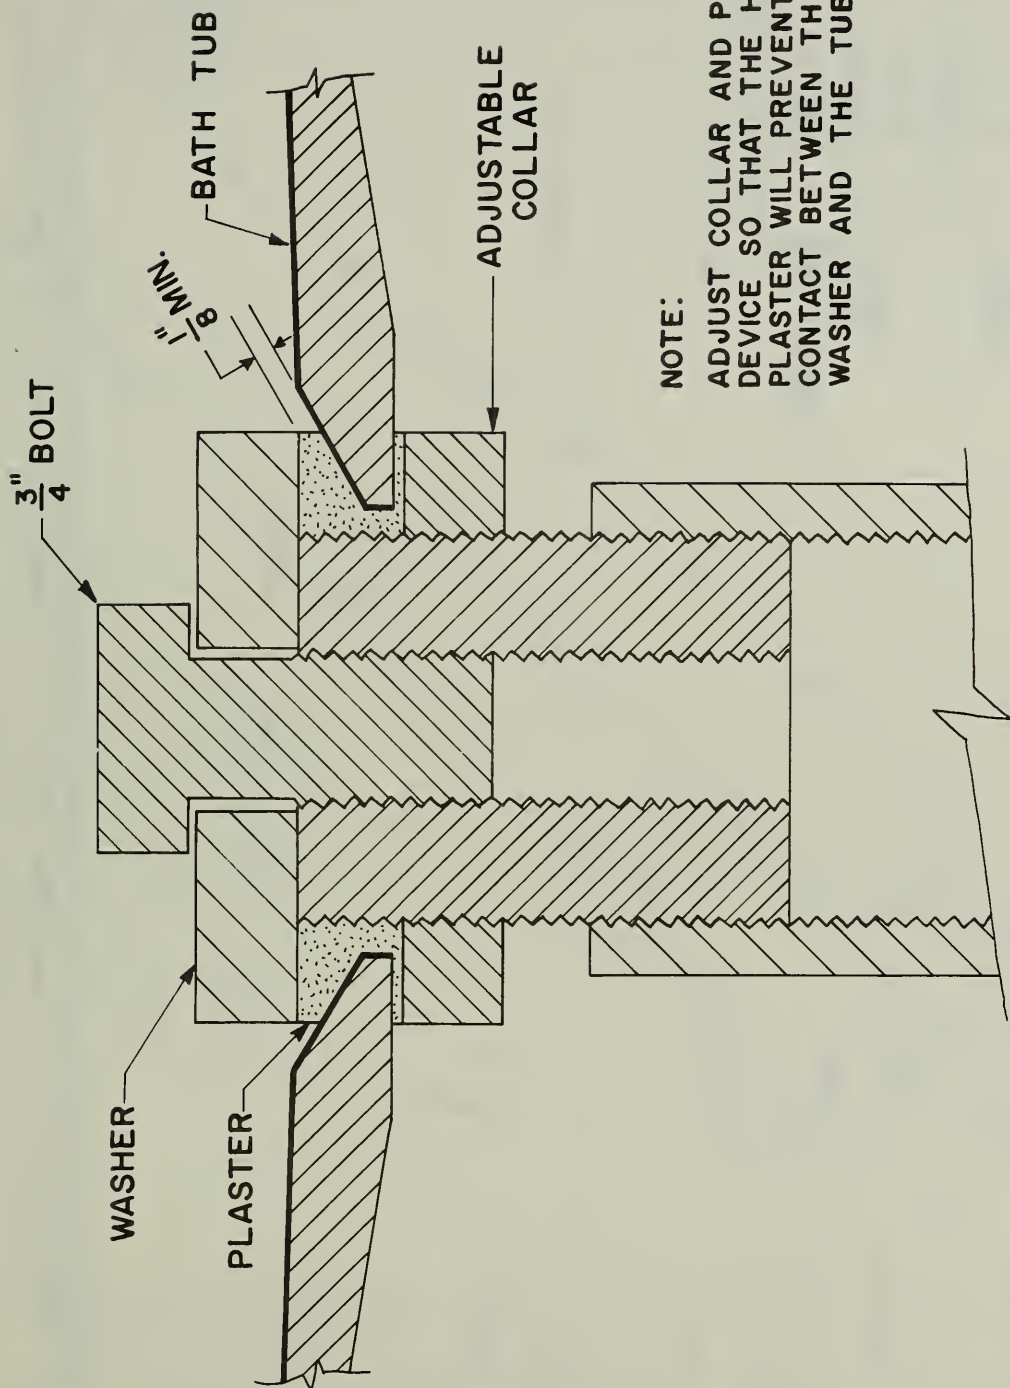
FIG. 2.6-2 INSTALLATION OF CONNECTING DEVICE FOR DRAIN FITTING LOAD TEST.

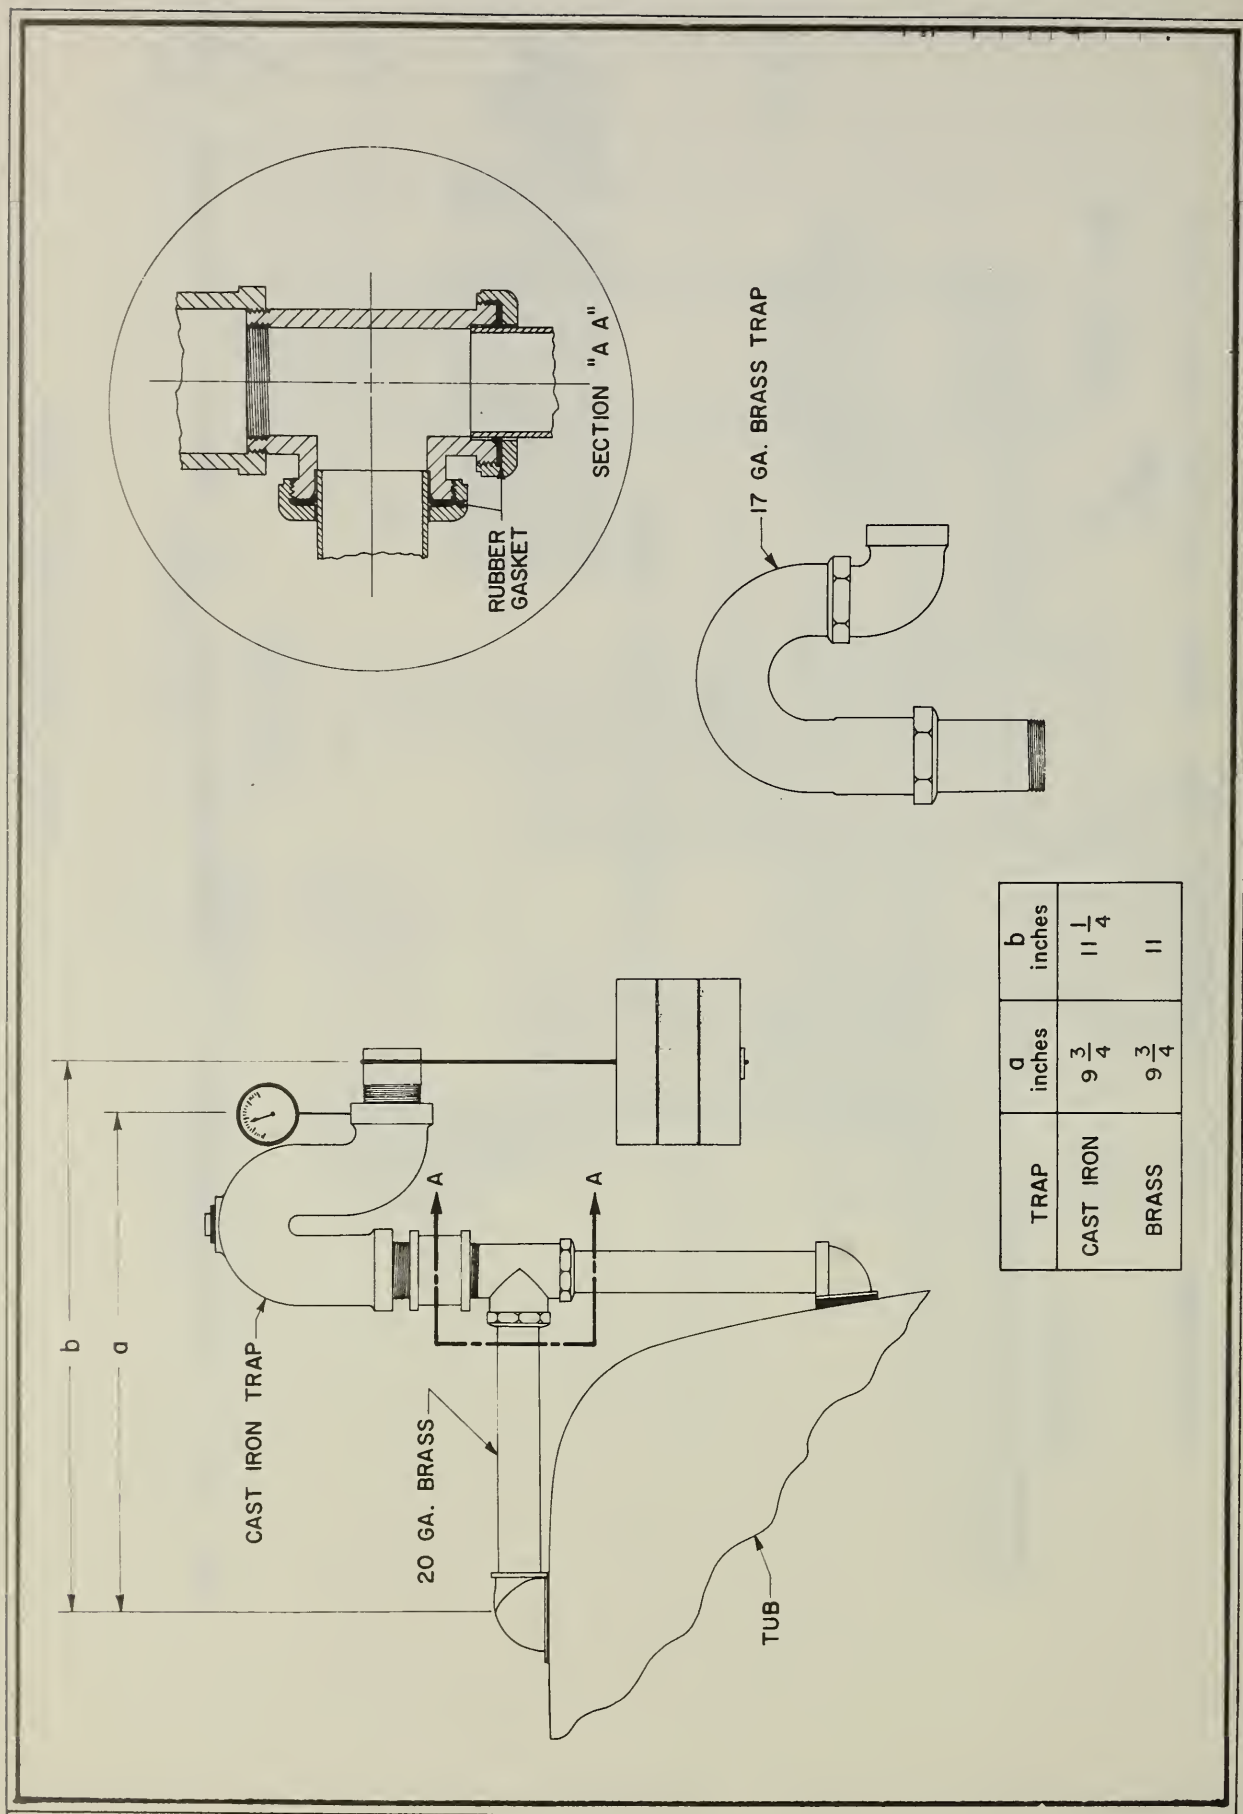
FIG. 2.6-3 TEST ARRANGEMENT FOR EVALUATING RIGIDITY OF COMMERCIAL DRAIN FITTING ASSEMBLIES.

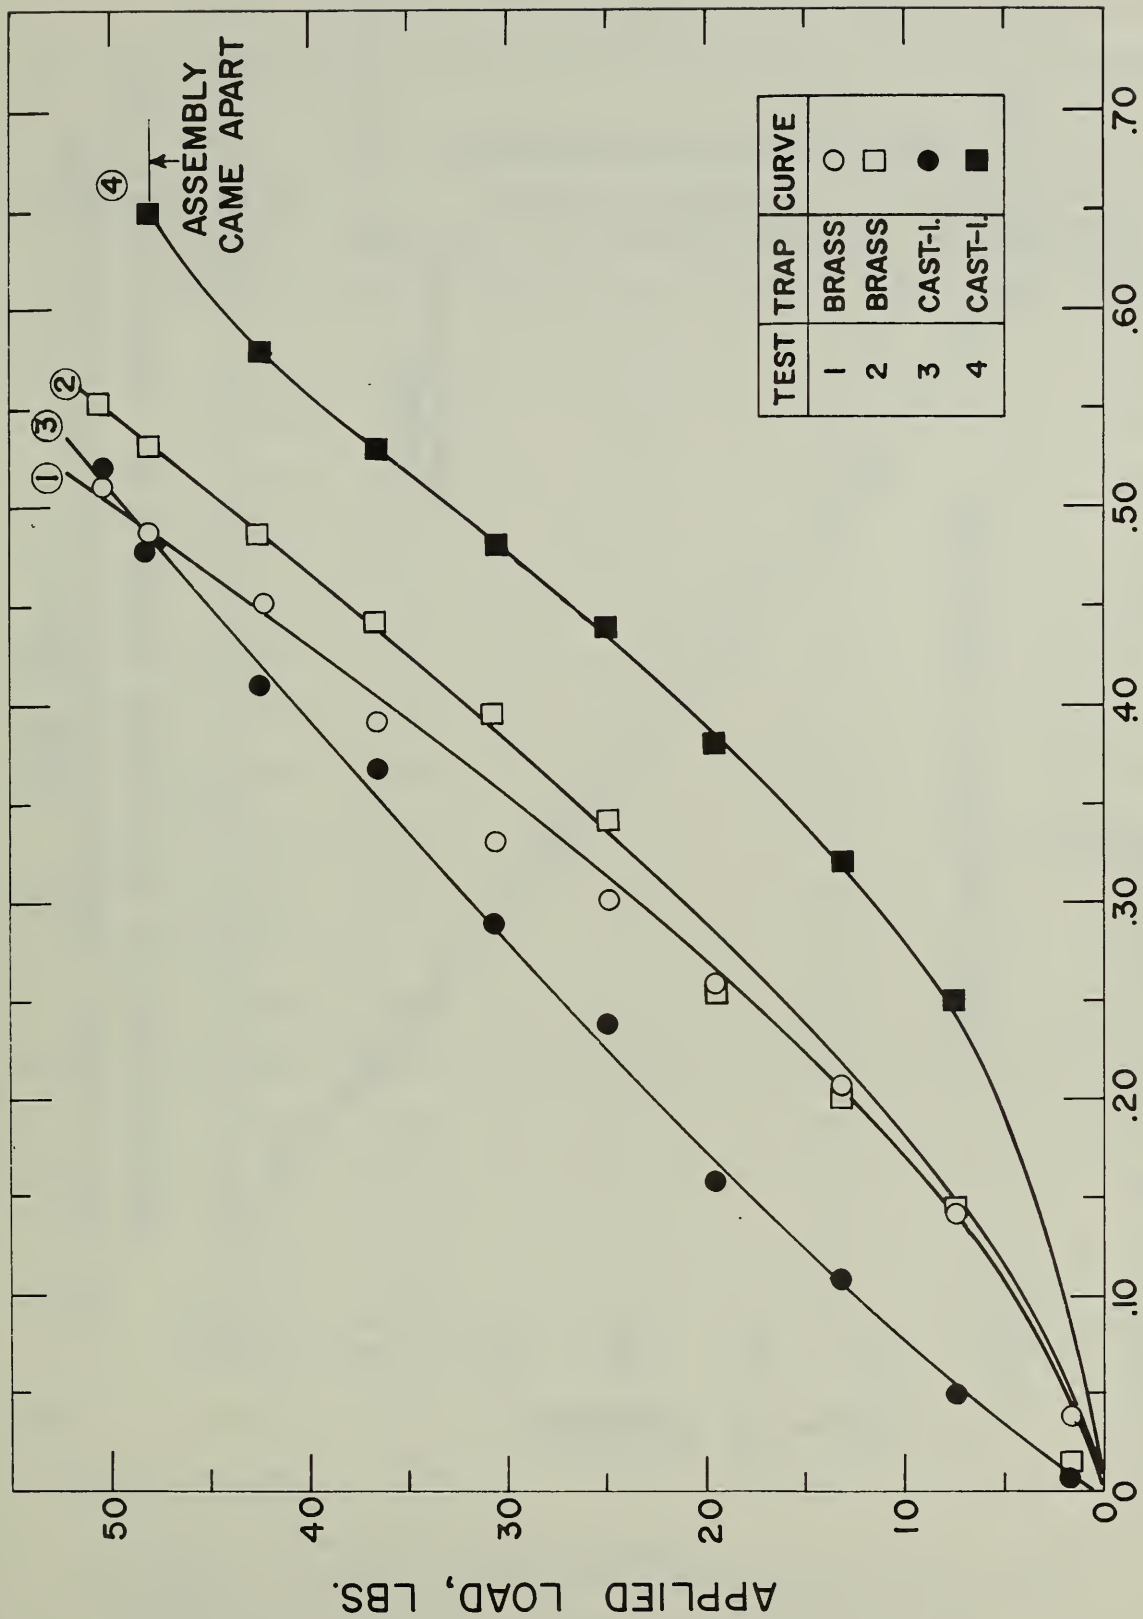
FIG. 2.6-4 TEST FOR RIGIDITY OF DRAIN FITTING ASSEMBLIES.

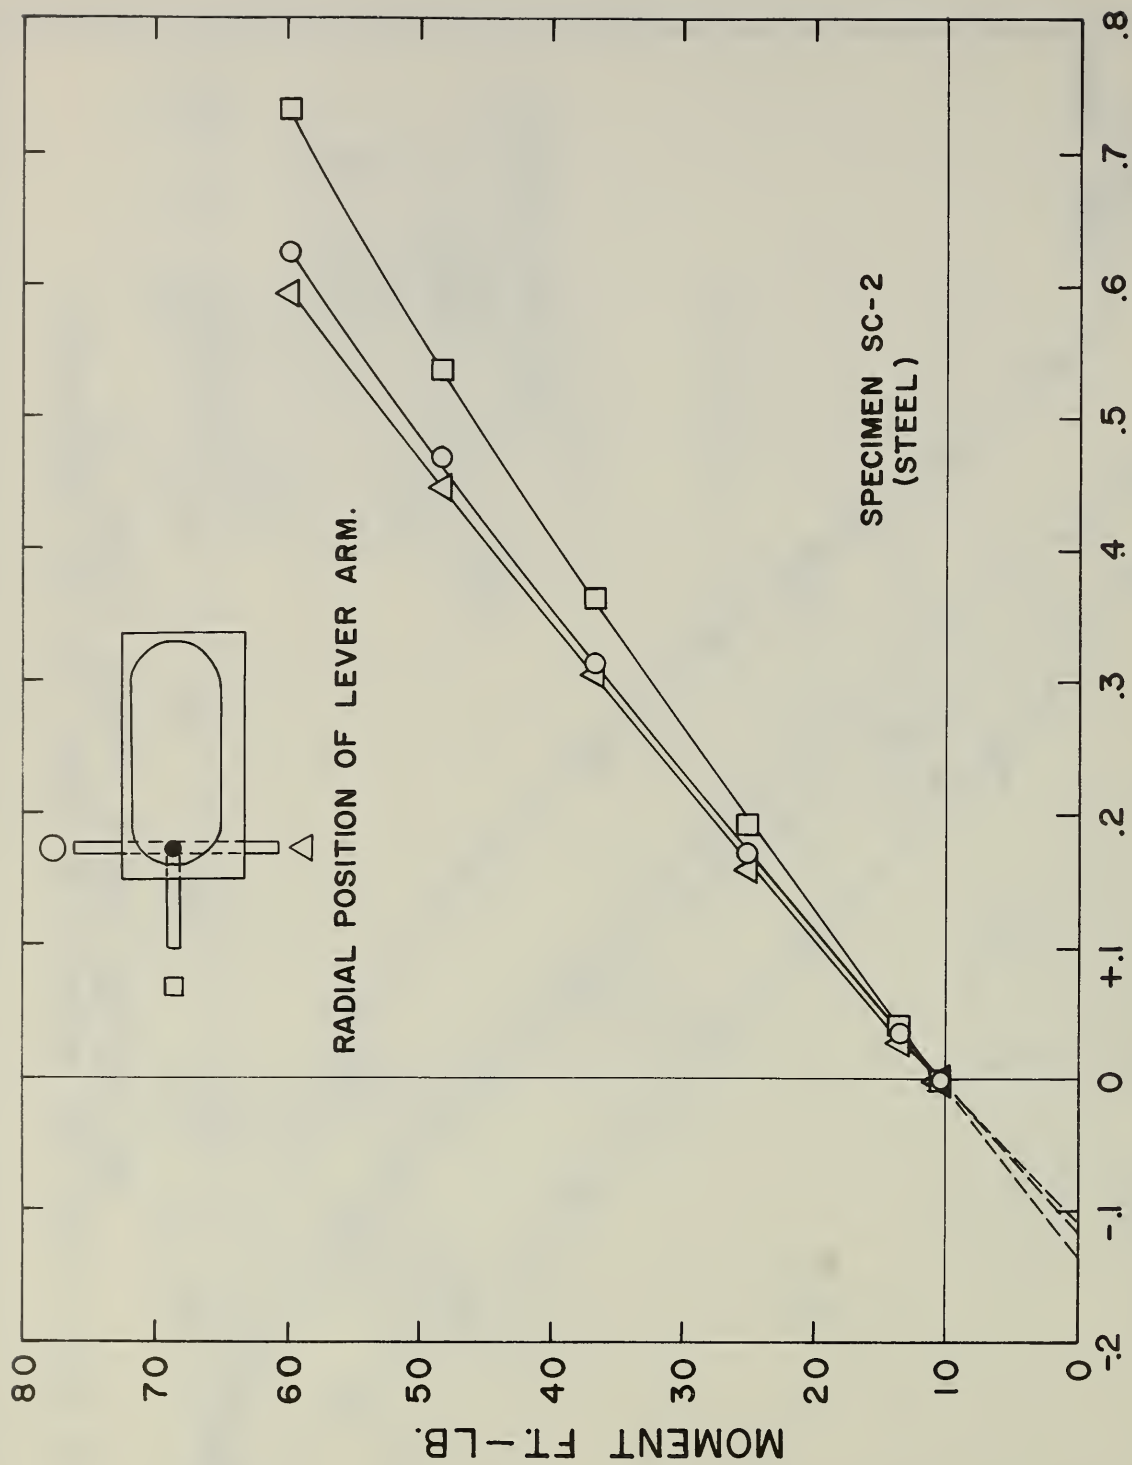
FIG. 2.6-5 TYPICAL MOMENT-DEFLECTION DATA FOR DRAIN FITTING LOAD TEST.

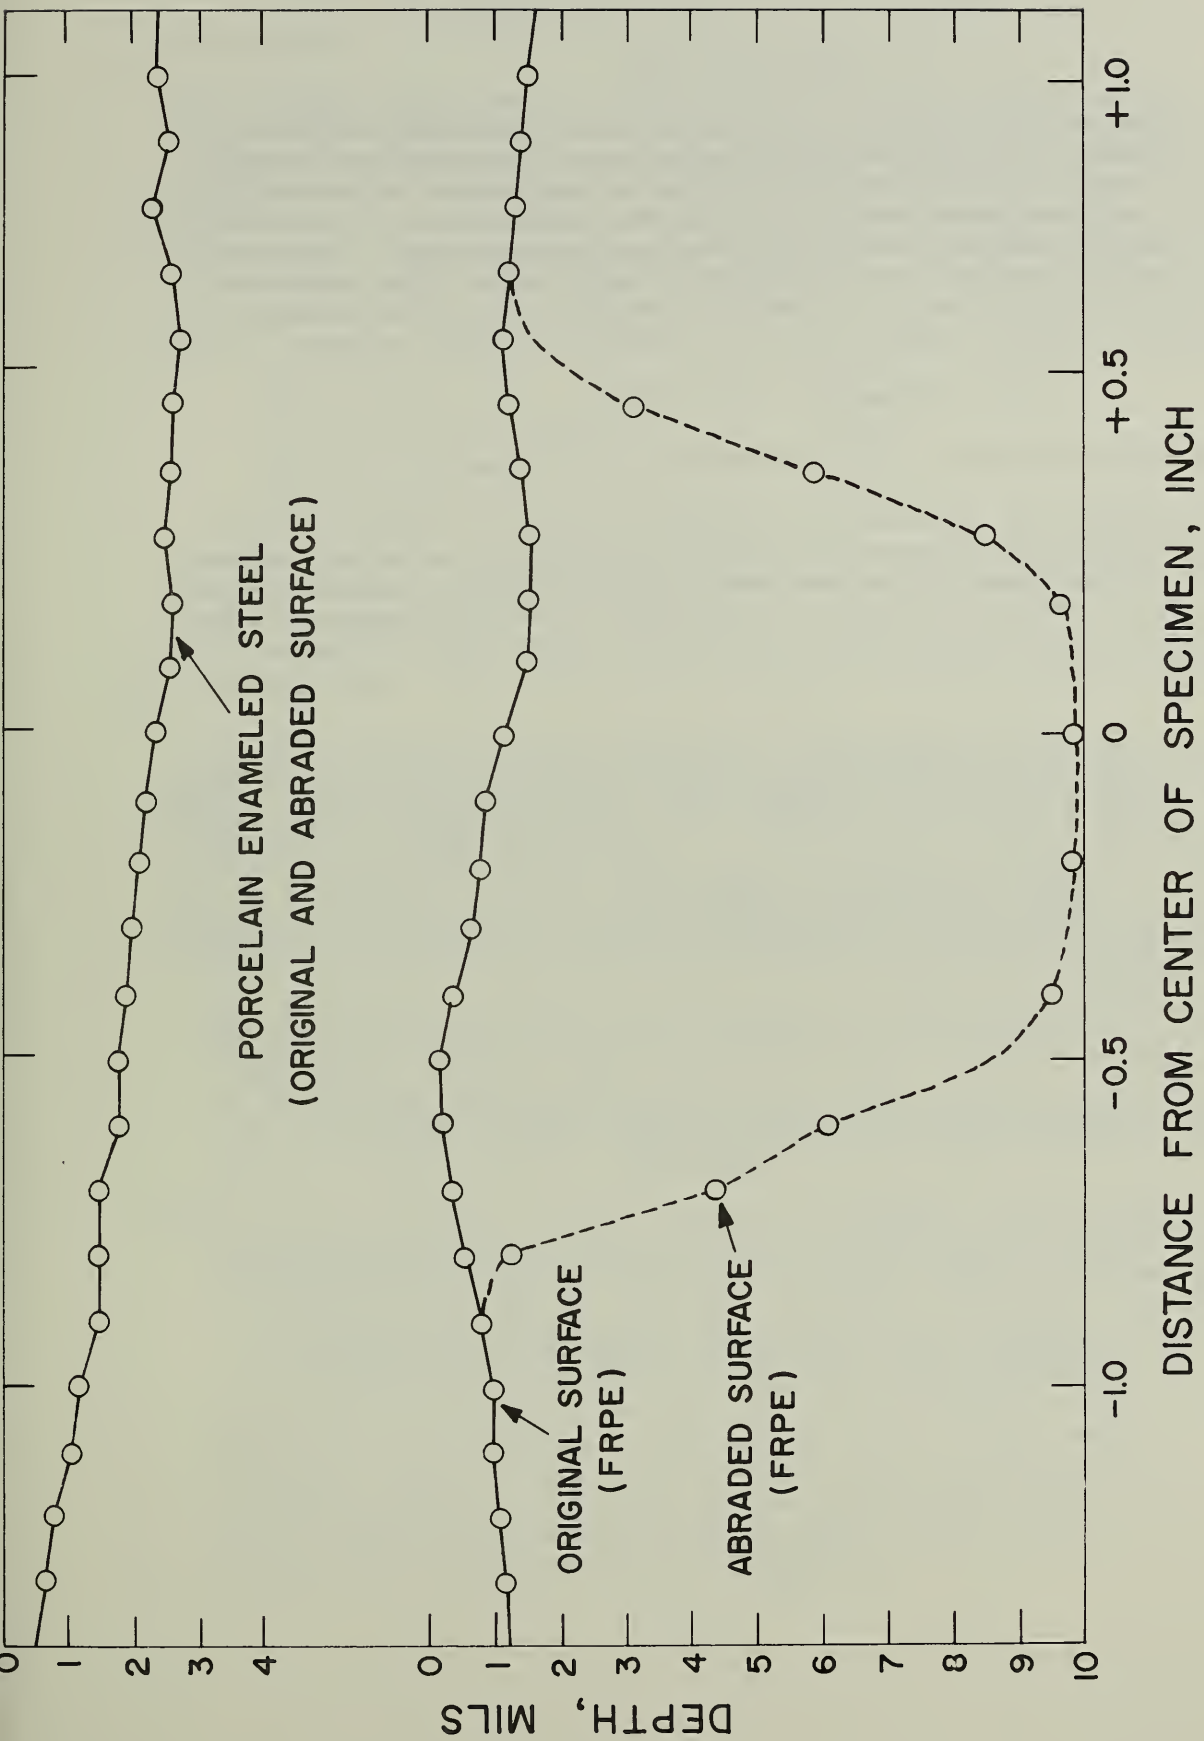
FIG. 210 - 1 PROFILES OF ORIGINAL AND ABRADED SURFACES OF PORCELAIN ENAMELED STEEL AND FRPE SPECIMENS.

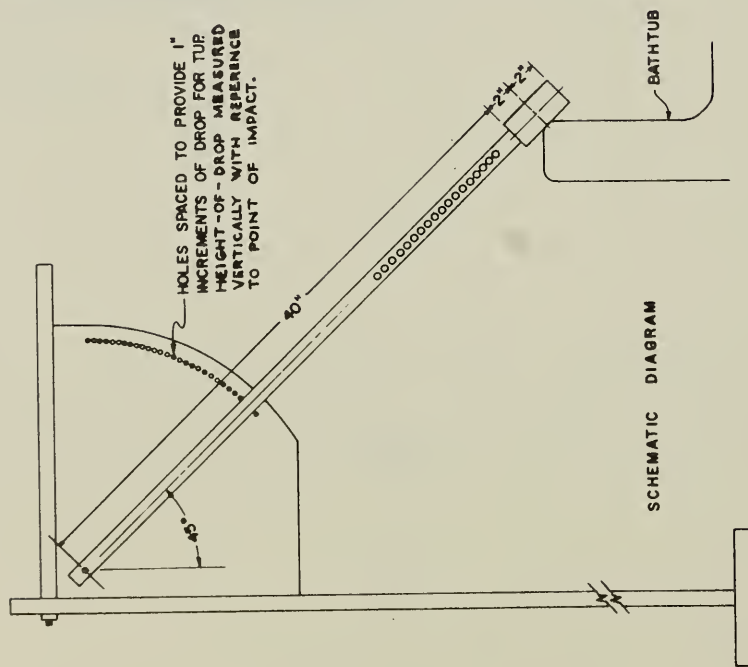
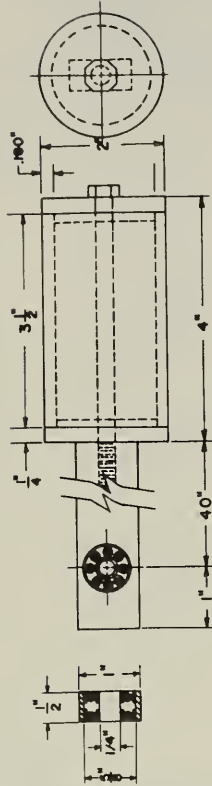
TUP 2" ROUND 6061-T6 ALUMINUM TUBING WITH .180" WALL THICKNESS. END PLATES MACHINED FROM 3/8" THICK ALUMINUM PLATES FOR SNUG FIT IN TUBING.

ARM 1" X 1/2" ALUMINUM BAR 41" LONG WITH 18 - 7/16" HOLES @ 5/8" O.C. STARTING 1" FROM TUP END OF ARM DRILLED AND TAPPED FOR 1/4" ASSEMBLY BOLT.

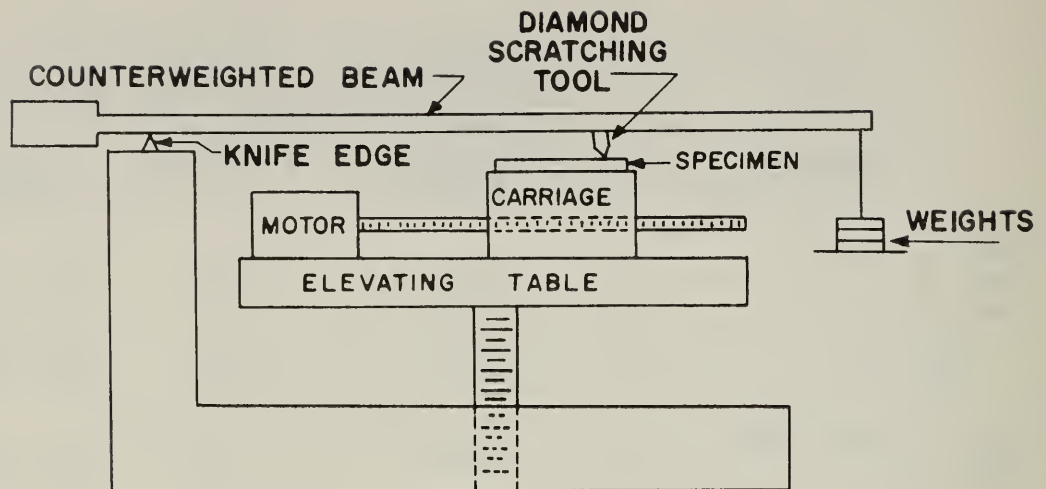
FIG. 2.16 -1. SCRATCH TEST APPARATUS

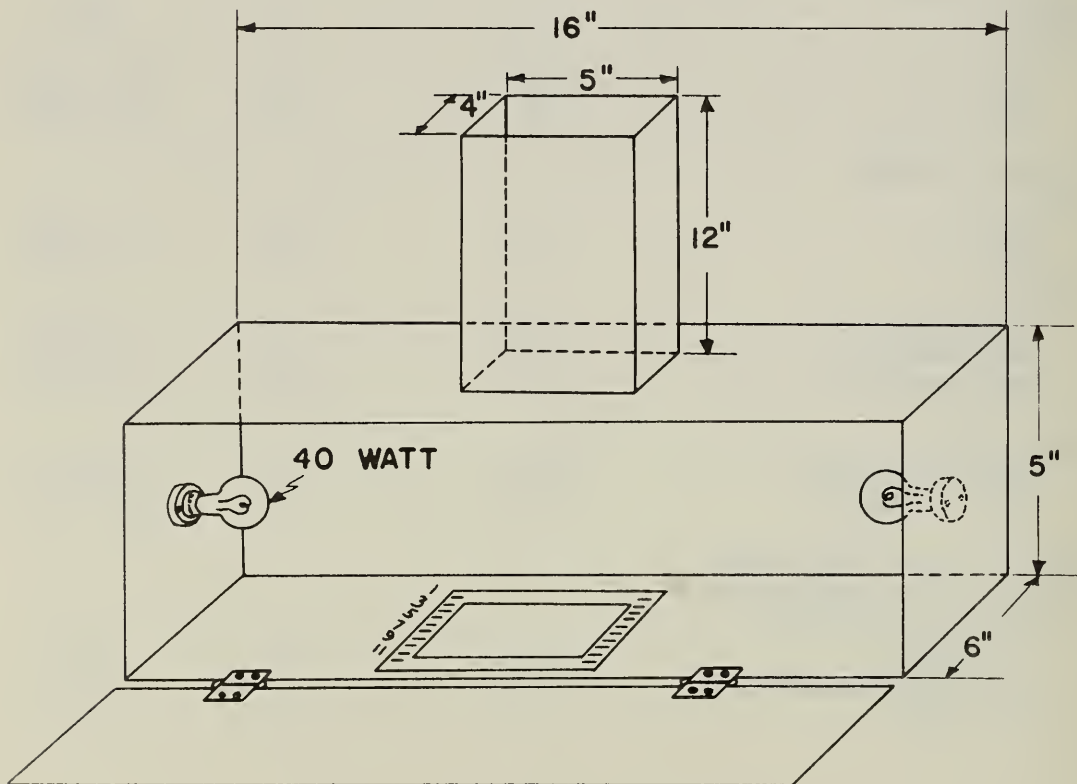
FIG. 2.16 -2. SPECIMEN VIEWING BOX

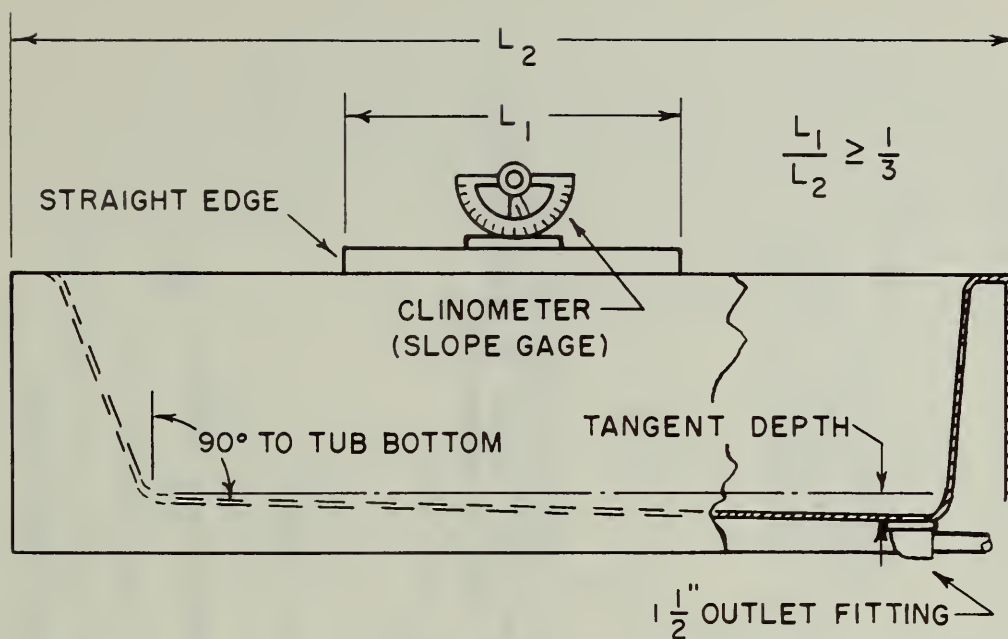
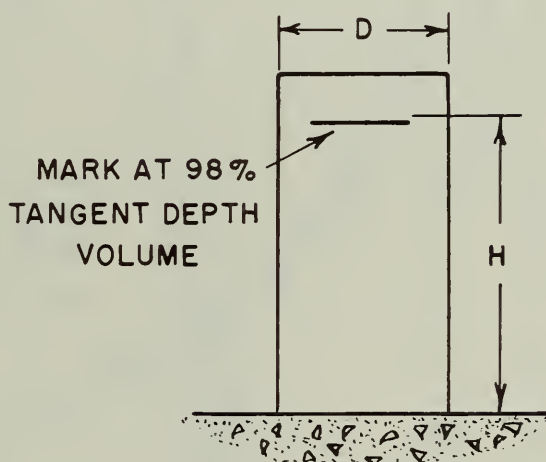
### BATHTUB

MOUNTED ON SUPPORTING STRUCTURE AS REQUIRED

1000 ml GRADUATED GLASS CYLINDER

$$\frac{H}{D} \geq 5.0$$

### RECEIVING VESSEL

PLACED ON LEVEL, STABLE SUPPORT

$$\frac{H}{D} \geq 2.0$$

FIG.2.17-1 — APPARATUS FOR DRAINABILITY TEST
